REPORT 8 TO THE STEWARDS OF THE RALLYCROSS NORWAY 2023

Document 6.3.8

SUBJECT: MATERIAL OF THE REAR FLOOR

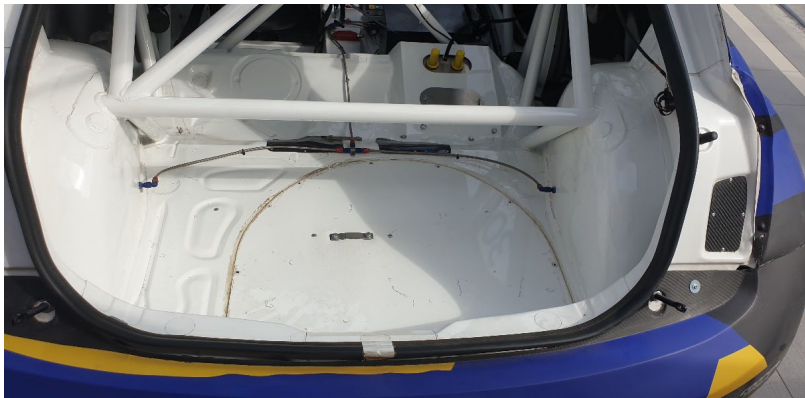
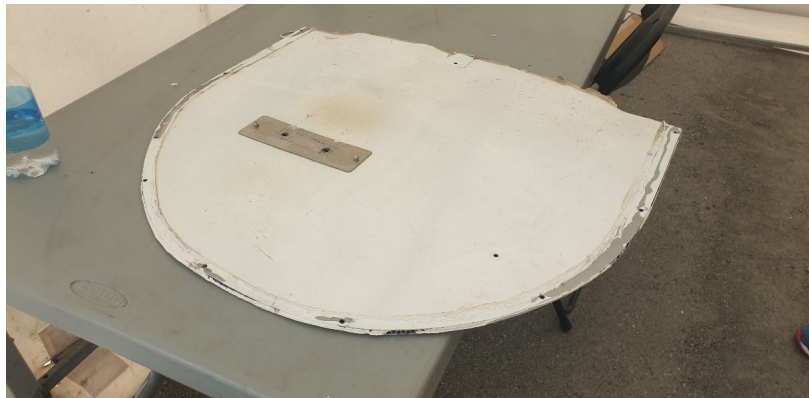
During the post-event scrutineering it was found, that RX3 car number 30 (driver: Nils VOLLAND) had a rear part of the floor made of aluminium. The construction of the floor was honeycomb, not sheet.

The size of the piece is 740mm x 680mm. Thickness is 6,50mm.
